# A Comparative Study on the Spatial Changes in Land-Use and Associated Environmental Impacts of Coastal Tourist Destinations: Hikkaduwa vs. Bentota, Sri Lanka

**ABSTRACT :** The tourism industry is one of the main economic activities of the southern coastal belt of Sri Lanka and is closely related to land-use as it dramatically transforms the natural land into highly artificial ones. The study focuses on the analysis of the spatial contrasts of land-use and environmental impacts in two coastal tourist destinations in the southern coast of Sri Lanka: Hikkaduwa and Bentota. For this, both primary and secondary data were used. Three samples, each consisting of fifty units from the local community, tourist stakeholders, and tourists, were randomly selected. Information regarding the environmental impact of tourism-driven land-use, obtained through three types of questionnaires, underwent descriptive analysis. Detection of land-use changes utilized various tools, including topo maps, high-resolution Google Earth images, and GPS-based ground truth observations.

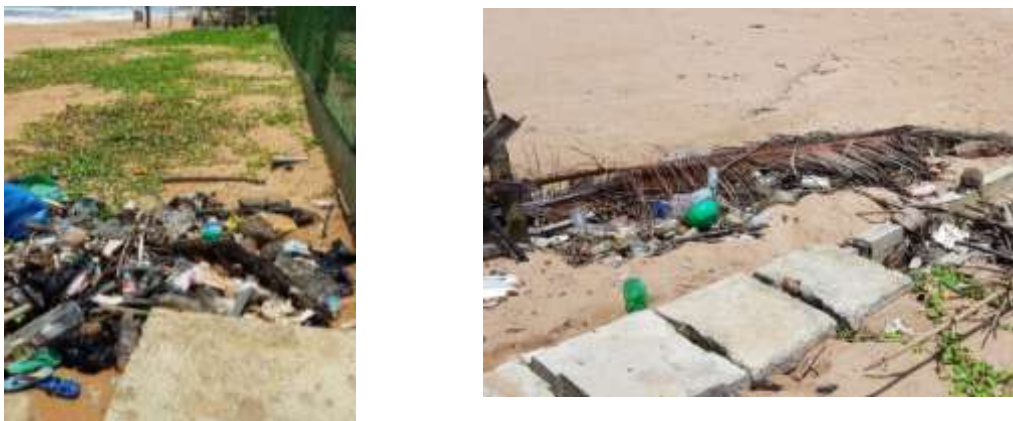
Figure 5: Irregularly dumped waste on the beach

Hikkaduwa faces significant issues with unclean beaches, littered roads, and land areas, which are commonly observed in the area. The community attributes this problem to multiple parties. Firstly, local tourists are identified as a primary contributor to the pollution of the beaches and land. Secondly, businesses associated with the tourism industry, including hotels, restaurants, and temporary shops, are also held accountable. Lastly, individuals from outside Hikkaduwa city are seen as another responsible party.

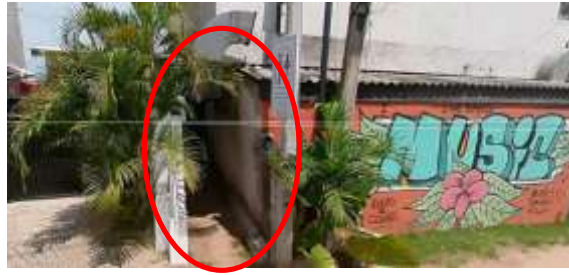
Figure 6: Paths to access the beach in Hikkaduwa  
Source: Field observations, 2022

In certain areas, the access roads to the beach are narrow, causing difficulties in reaching the beach freely, especially during the peak tourist season. Temporary booths constructed along the road further obstruct the access. Additionally, due to the high density of buildings, tourists are forced to navigate through very narrow paths between two structures in order to reach the beach. Furthermore, the natural beach views are significantly hindered by large walled buildings that have been erected between the beach and the main road.

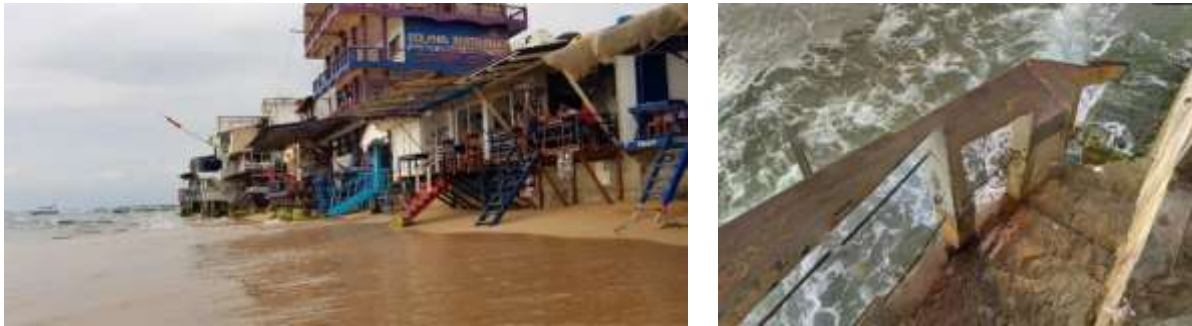
Figure 7: Coastal erosion in the north section of the Hikkaduwa beach  
Source: Field observations, 2022

Coastal erosion is a significant problem in Hikkaduwa, resulting in damage or loss of coastal structures, loss of valuable land, and disruption of human activities like fishing and recreation. Some people believe that the erosion has reached its maximum level and there is no more beach left to erode. As a result, it is difficult to find a clear, uneroded coastline from Hikkaduwa to Narigama for promoting coastal tourism. The community has noted that compared to the past, Hikkaduwa has smaller, scattered, and narrow beaches with no wide, continuous coastline.

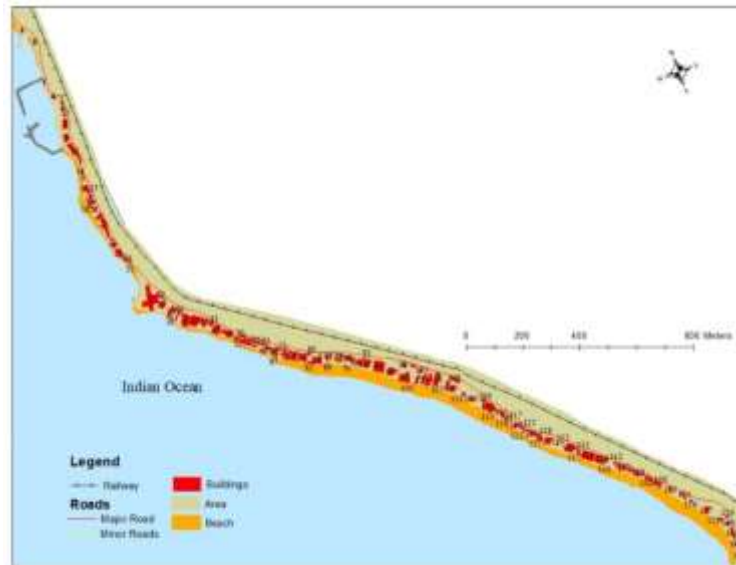
Figure 8: Beach access and land use by tourist establishments, shops, and private houses in the coastal strip between the main road and sea

The Coast Conservation Act No 57 of 1981 states that anyone planning "development activities" within the coastal zone, which extends 300m inland from the mean high-water mark, must comply with permit requirements regulated by the CCD. Due to the significant economic contribution of Hikkaduwa tourist town, the institutions responsible for coastal conservation have relaxed the rules and regulations surrounding tourism development activities on Hikkaduwa beach to some extent. However, this leniency in institutional regulations has resulted in informal land use practices and severe coastal erosion along the Hikkaduwa coast today. The beachfront length (in meters) of tourist establishments, shops, and private houses located in the coastal strip of Hikkaduwa is depicted in Fig. 8.

In the Hikkaduwa beach area, out of the 166 establishments identified, around 73.4% (122 establishments) have a beachfront area of fewer than 50 meters. Unfortunately, there is severe erosion along the beach, stretching from the Coral Sands Hotel in the north to the Citrus Hotel in the south. To combat the erosion, hoteliers have been constructing retaining walls and filling the areas between the buildings and the walls with sand. This has led to a reduction in the available beach area for visitors and recreational activities. In some cases, such as at the Coral Reef Hotel, Mama's Beach Restaurant, and Coral Rock by Bansei, there is no beach remaining due to the encroachment and construction efforts.

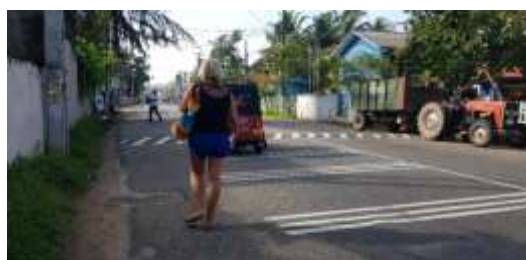
Figure 9: Absence of a sidewalk near Hikkaduwa beach on Galle-Hikkaduwa main road

The lack of a sidewalk on the A2 road has posed significant challenges, particularly in a tourist hotspot where thousands of tourists frequent. The absence of a sidewalk has resulted in a large volume of pedestrian traffic on the road, which is quite unsafe considering the presence of buses, trucks, and lorries. Unfortunately, accidents involving tourists have occurred multiple times on this stretch of road. Compounding the issue is the limited space available due to buildings constructed close to the main road, making it impossible to widen the road and construct a sidewalk.

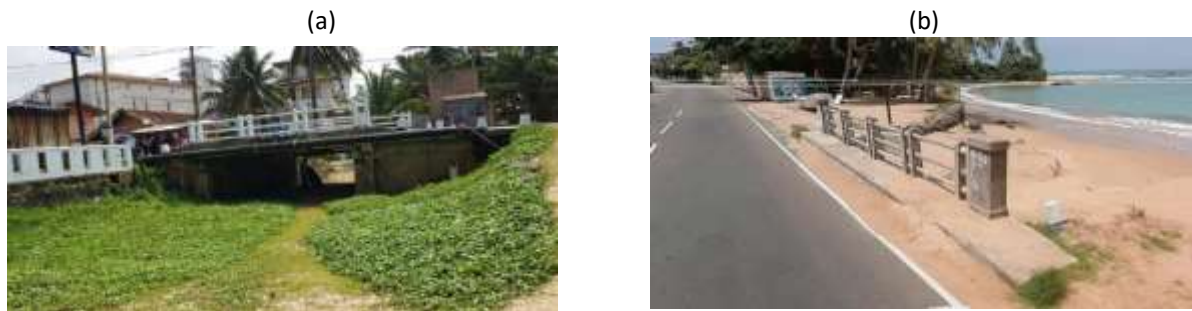
Figure 10: Outlets of Tuduwegoda canal (a) Mawakada canal (b) are filled with sand

One of the major environmental concerns in Hikkaduwa is the pollution of inland waterways that eventually connect to the sea. Within the study area of 36 km<sup>2</sup>, there are two canals, namely the Tuduwegoda Canal and the Mawakada Canal, which serve as outlets for excess rainwater to flow into the sea through the Hikkaduwa municipality. The Thuduwegoda Canal joins the Thelwatta ganga (Molapu oya) and empties into the sea from Wavulgoda west GND, while the Mawakada Canal flows into the sea near Hikkaduwa beach, where most tourist activities take place at Pannamgoda GND (Fig.10). These canal outlets are periodically obstructed by sandbar formations throughout most of the year, exacerbating the issue (Fig.11 & Fig.12).

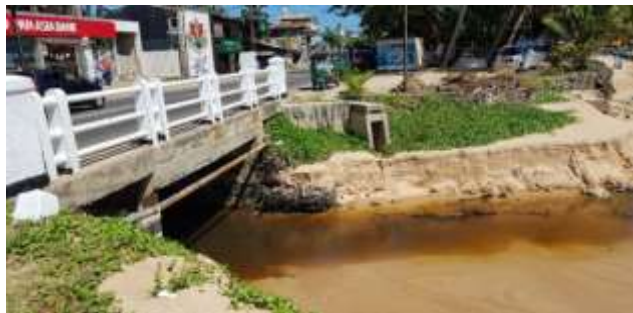
Figure 11: Mawakada canal is connected to the sea by cutting the sandbank

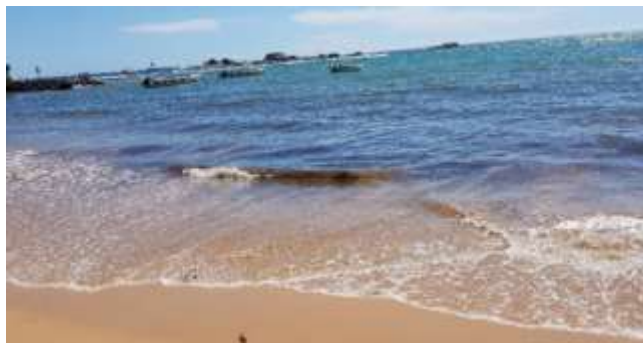
Figure 12: Dirty water from the canal has accumulated in the sea near Hikkaduwa beach
